FEASIBILITY STUDY for
ADAPTIVE REUSE

for
THE MURPHY HOUSE
Wilmington, Delaware

July, 2010

JOHN MILNER
ARCHITECTS, INC.

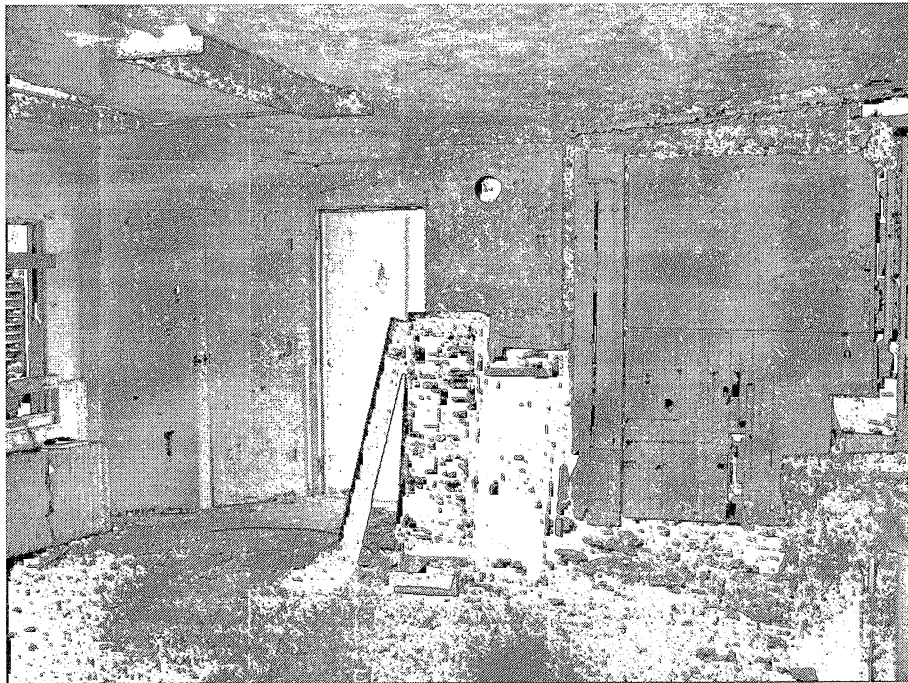
First Floor – Kitchen South Wall

Condition: The original, rear door to this space is missing; there is beaded wood wainscot throughout the room and a beaded wood built-in full height corner cabinet in the northwest corner. Window sashes, apparently for the majority of the windows of the house, are stored in this room. There are two (2) window openings on the west wall and a window, door and enameled porcelain sink on the east wall. There are minimal other built-in shelves and cabinets. The floor is soft and in very poor condition in the south half of the room and the two (2) radiators appear to be collapsing through the floor on the west side. The plaster ceiling is intact.

Recommendation #13: Remove existing flooring and subflooring (entire room); re-frame floor structure of entire room, install new plywood subfloor and wood finish floor. Frame new interior partition walls for Half Bath, Print Room and Pantry, and install new wall, floor and ceiling finishes.

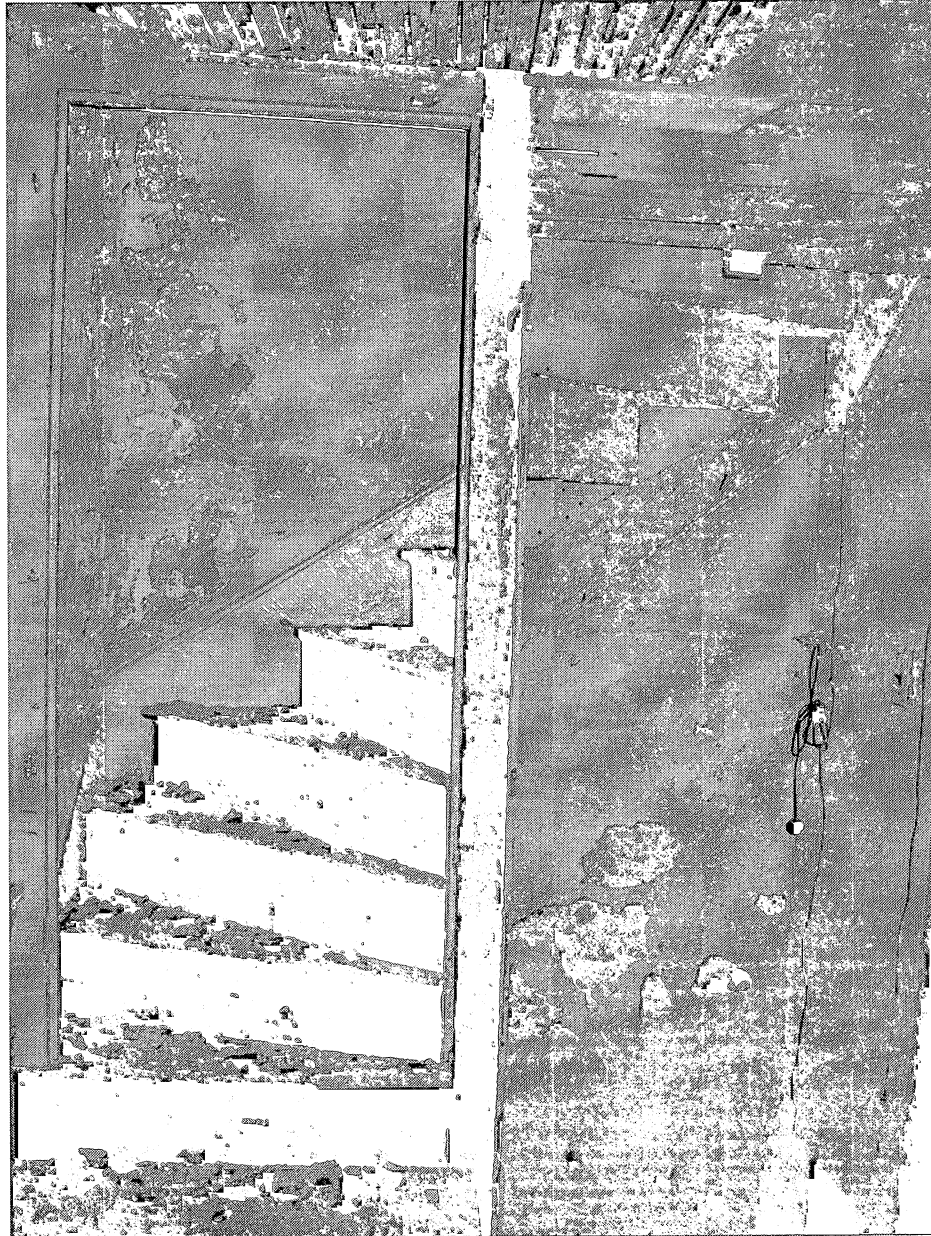
First Floor – Winder Stair

Conditions: The only means of vertical circulation from the basement to the first floor, and the first floor to the second and attic is by means of an original box winder stair located in the northeast corner of the main block of the house. The stair construction is in good condition except for some failed treads and support structure at the lower part of the flight nearest the floor of the basement, presumably from earlier deterioration or insect damage. Regardless of condition, these stairs do not meet current building code and could not be used for a commercial re-use.

Recommendation #3: Construct a new code compliant stair in an enclosure at the northeast corner of the open wrapping porch, over the area where the porch has a basement beneath its floor. This will solve the vertical circulation problem of the non-compliant stair and also help to protect the area of the basement from leakage through the open porch floor. An area to the north of the new stair enclosure would still consist of an exterior floor over a basement, and would need a waterproof floor covering. To place an architecturally compatible roof over this enclosure, a code compliant stair would not be able to be installed to the third floor. Since the

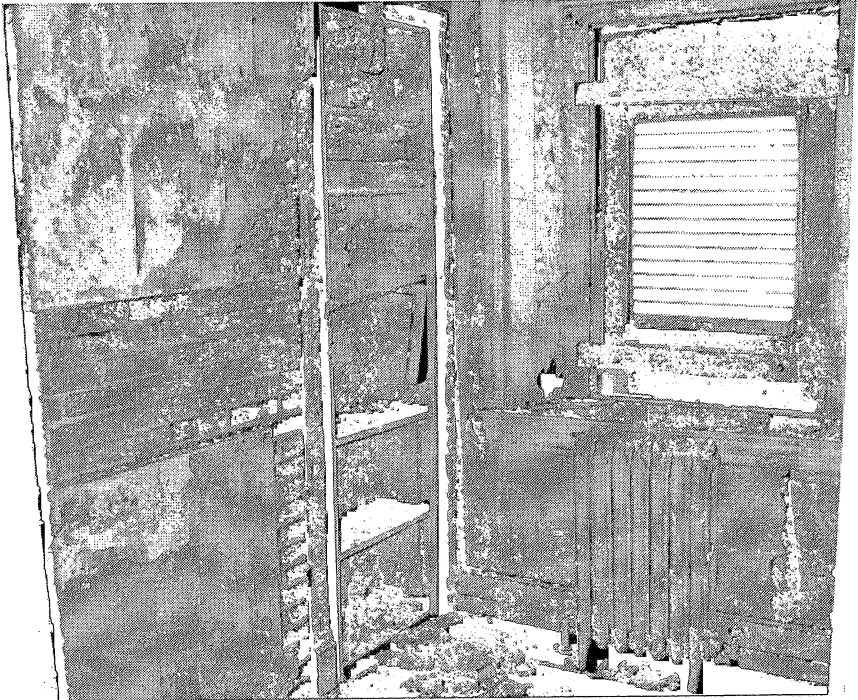
First Floor – Living Room

Condition: The original Living Room is located in the southeast corner of the oldest portion of the house, with a large, brick fireplace on the east wall. The firebox is plastered over and the mantle is missing. To the right of the fireplace is a cupboard, which is missing its doors; to the left is the box winder stair, also with no doors. In front of the stair the ceiling plaster is collapsed, exposing the structure above that consists of 4" x 7-1/2" floor joists spanning north-south at 24 centers. There is one south facing window, window and door trim are intact. The front (exterior) door is missing; Greek Revival paneled door jambs and head are intact. 5-inch to 6-inch wide floorboards are intact. An intact stud and plaster wall partition separate this room from the Parlor to the west.

Recommendation #15: Restore existing windows; install a new or period exterior door, and new replica period interior doors. Replace the missing mantle and restore/refinish existing woodwork and built-ins including new cabinet doors.

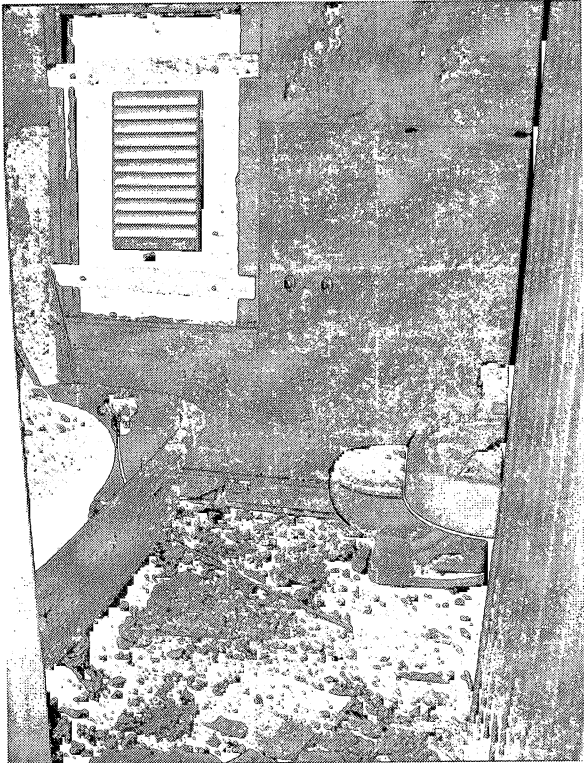
Second Floor - Bathroom

Condition: The bathroom contains a claw foot tub, wall lavatory and toilet and a lot of miscellaneous debris. Window and door casings are flat trim with minimal scratch bead edges; beaded door to the hallway is intact. Plaster walls and ceiling are moisture-damaged and floorboards are partially collapsed.

Recommendation #21: Renovate existing Bathroom into Half Bath/Pantry combination. Remove all plaster to install insulation and new utilities and to repair the conditions at the floor

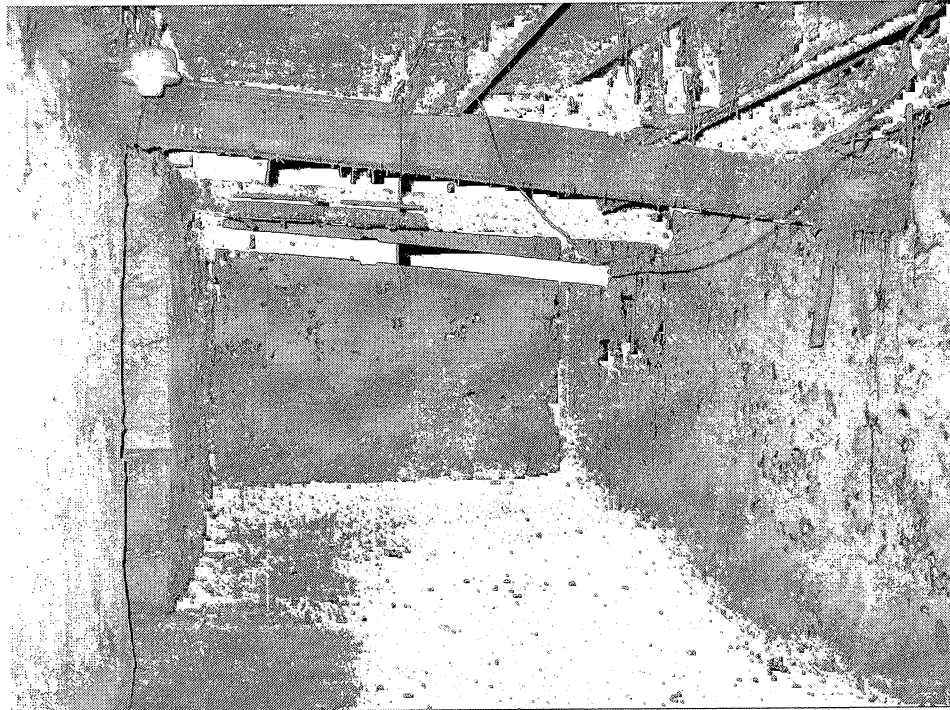
Basement – Under Existing Porch

At the northern side of the wrapping porch, the porch floor is a concrete slab on grade; however, at the eastern side, the floor is a plywood surface covering wood framing, which spans over a basement beneath that section of the porch. The floor of the front porch is wood framed over a continuous masonry foundation with painted board flooring, and a single stone step down from the porch to grade.

Recommendation # 9: Re-frame the east floor of the wrap-around porch (north of where the new stair and enclosure will be located), and install a waterproof floor material above.

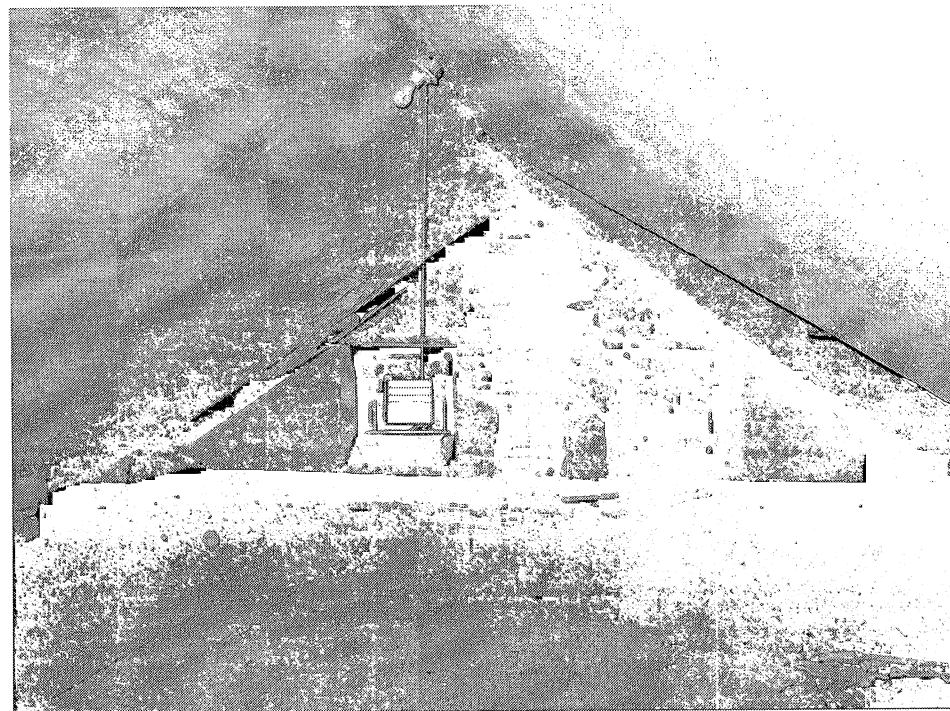
Attic – Front Portion

Condition: The third floor or attic room over the earliest portion of the house has plastered stone knee walls near the eaves, approximately 1-foot high, with 6-feet of headroom under the roof ridge. There are wide pine floors, partially covered with linoleum. The undersides of the rafters are plastered except for two large areas of lost plaster and damage caused by roof leaks in the roof valleys. There appears to be recent roof leakage at the northwest roof valley. Evidence of plaster in-filled openings indicates that there formerly were two (2) dormers at the south (front) roof slope of this attic.

Recommendation #22: Remove either the plaster ceiling or the wood floors for installation of insulation. Install new railing and gate at the top of the winder stair. Make masonry repairs at west chimney; rebuild north and east chimneys from the attic floor, through roof to top.
