Blue Ball Properties Master Plan

FEASIBILITY STUDY FOR THE STABILIZATION OF HISTORIC STRUCTURES

April 2000

The George Murphy House

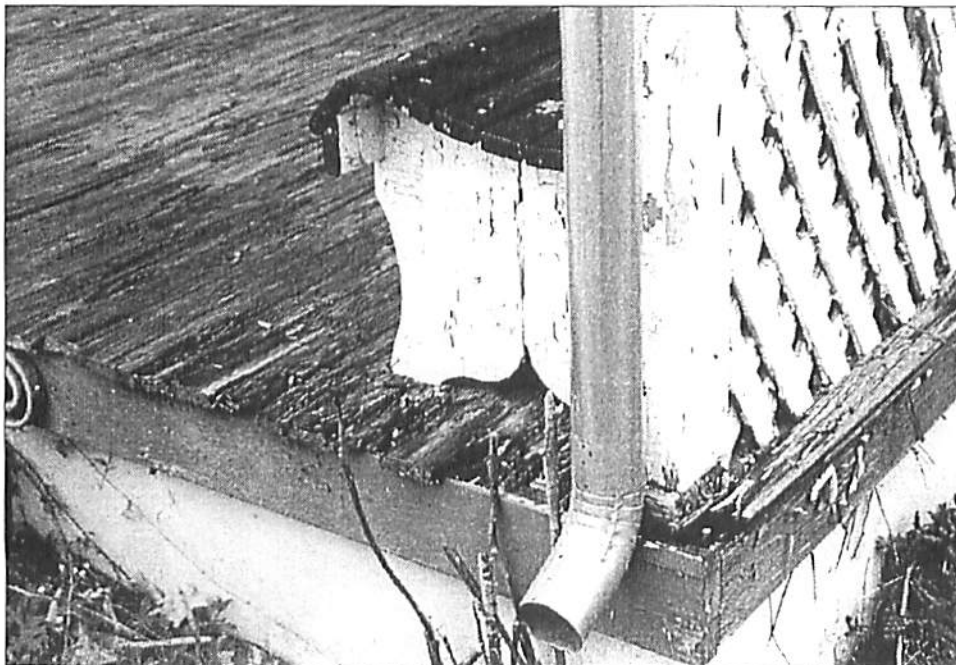
Figure 8. Evidence of water damage to the floorboards of the front entrance porch.

1. Repair soffit of wood front entrance porch and repaint. Assume soffit is 26' x 8" high.
2. Repaint floorboards of front entrance porch. Assume 169 sf to be painted.
3. Extend existing downspout at front entrance porch approximately 12" to grade.
4. Have the building examined by a certified company for signs of active insect infestation, and take necessary steps if evidence is found.

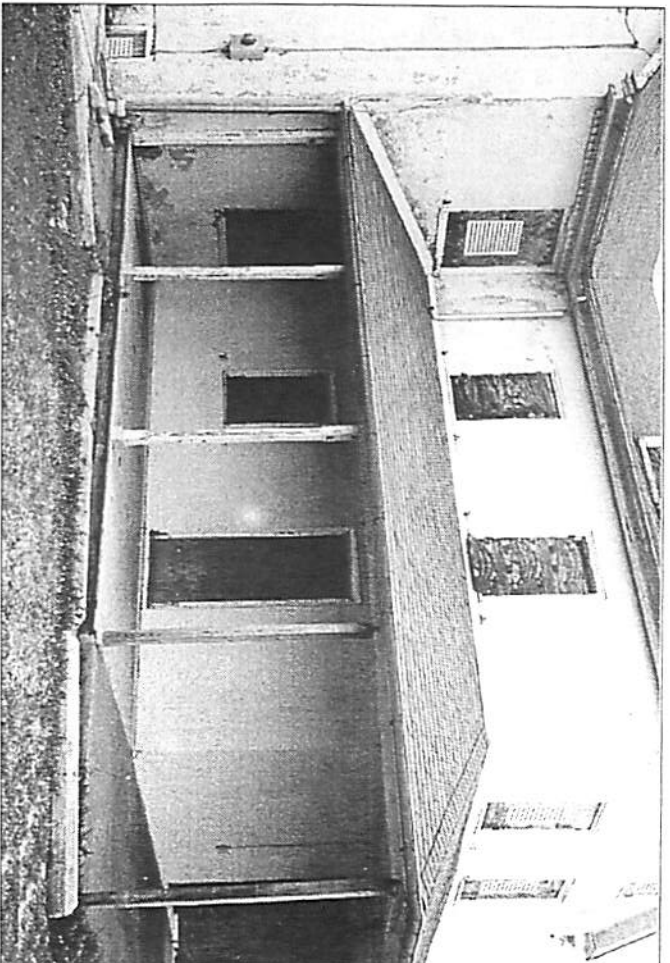
The one-story, wood porch that wraps around the frame section of the house has a hipped roof supported by seven chamfered wood columns (Figure 9). Like the front entrance porch, the wraparound rear porch shows moderate water damage including peeling paint, warped ceiling boards, and stained wood framing members. There also appears to be evidence of termite damage to the wood joists that frame the porch roof. The ends of several of the porch rafters have been sistered in recent years and appear to be structurally sound, as do the porch columns (Figure 10). The existing roof and downspout/gutter system on the porch should help to protect it from further damage.

Figure 9. View of the wraparound wood entrance porch on the east elevation of the house.

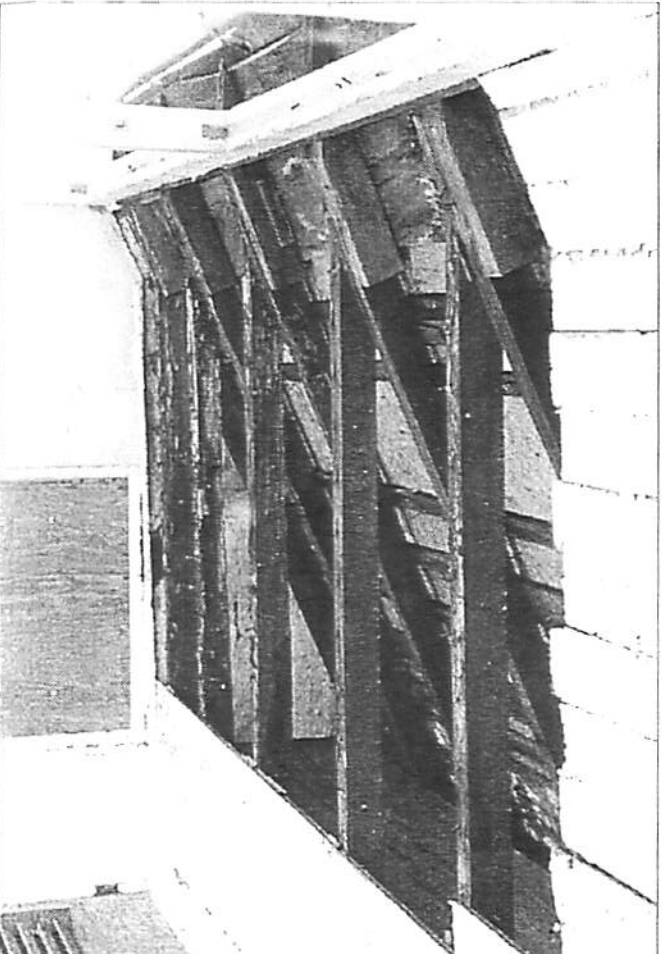
Figure 10. View of the underside of the ceiling of the wraparound porch. Note the sitered porch roof rafters and the insect damage on the roof joists.

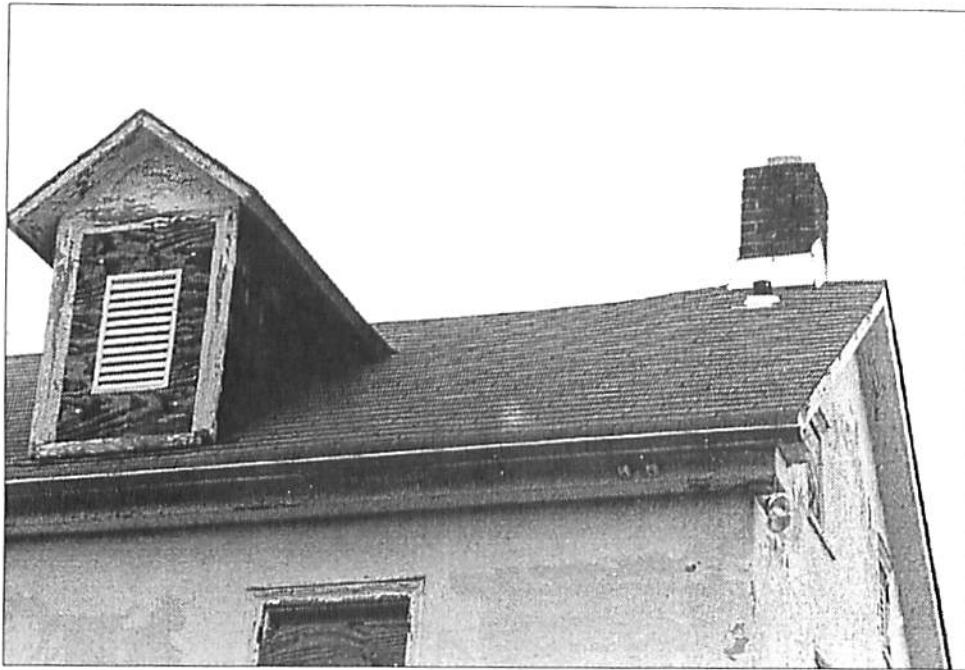
The stone and wood frame sections of the house share a new asphalt-shingled roof and new aluminum gutters and downspouts (Figures 5 & 11). The two porches also have new asphalt-shingled roofs and gutters. All of the roofs and gutters on the building are in excellent condition. The replacement of the old wood-shingle roofs on the building with new asphalt shingle roofs, new flashing, and new gutters have helped to effectively stabilize the building. While puddles of water were found on all levels of the house, very little of this water appears to have entered the structure through the roof. Only one minor roof leak was detected in the attic (Figure 12) below a valley where the roof of the frame

Figure 11. View of the new asphalt-shingle roof and new gutters.

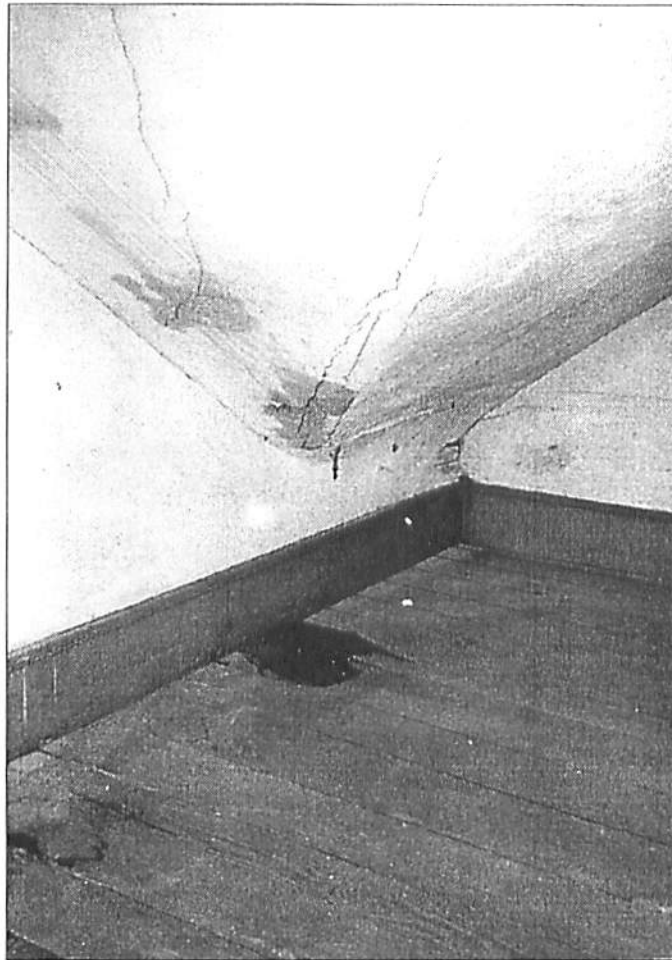
section of the house met the roof of the stone portion of the building. The flashing in this section of the roof should be checked and repaired as required. To ensure that the roof continues to function effectively, it is recommended that the house's gutters be periodically cleared of debris and checked to ensure that they are performing as designed and draining water away from the eaves and foundations of the structure.

Figure 12. View of minor roof leak in attic. The roof should be examined above this leak and repaired.

1. Examine roof at valley above attic leak. Repair flashing and shingles as required.

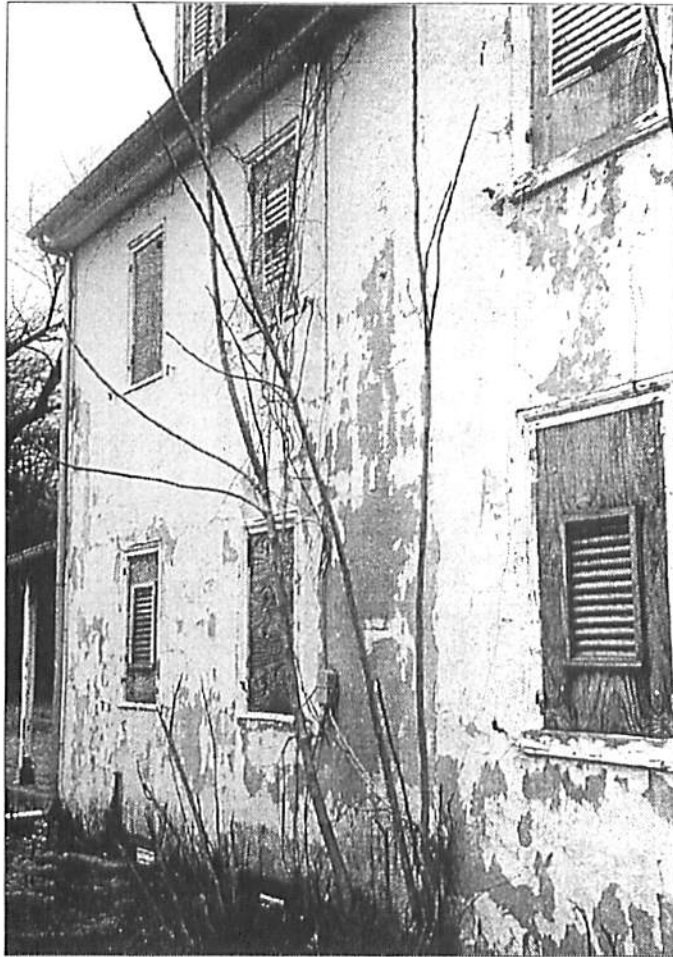
Figure 13. *The window and door openings on the Murphy House were sheathed with vented plywood panels. This was an appropriate stabilization procedure.*

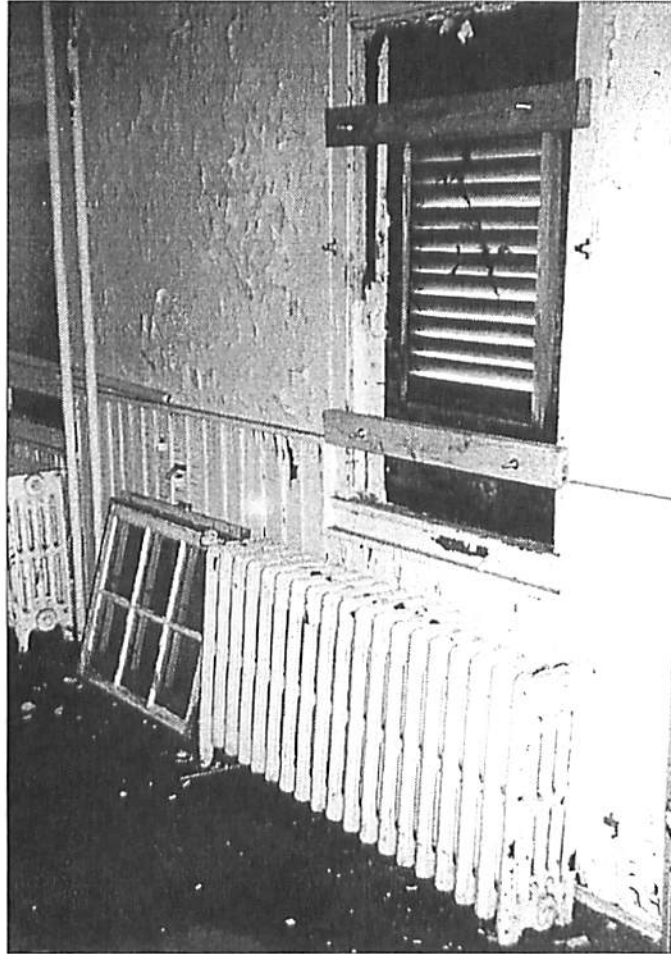
Figure 14. Pairs of metal bolts and wood 2 x 4s on the interior of the house hold the exterior plywood window panels in place.

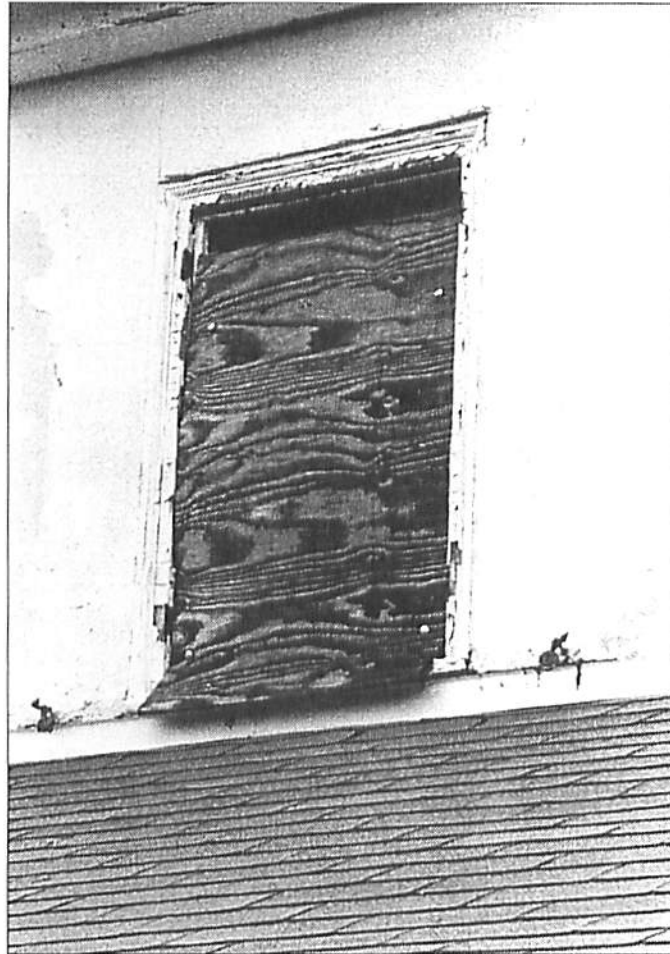
Most of the existing window sashes have been removed from the structure. The sashes that remain and the historic jambs that are all still intact appear to be in fair condition and will not further deteriorate as they are now protected from the weather. The plywood panels that shield the window openings are in fair-to-poor condition. They appear to have been cut from standard rather than marine-grade plywood and are not holding up well to the effects of the weather. They are delaminating, warping and even slipping out of position (Figure 15). Also, some of the plastic vents in the panels are losing their louvers and are in need of replacement (Figure 16). Most critical, however, is the fact that water appears to be blowing into the building through the louvered openings. Water has soaked the floors of several rooms in the house (Figures 1, 2 & 17), and has caused floorboards to warp and mold to grow. Since wet wood floors and floor joists create an attractive environment for termites and carpenter ants, these wood elements should not be allowed to remain damp. It is recommended that the existing plywood panels be replaced with vented, painted, marine-grade plywood panels. It is also recommended that metal hoods be placed above the existing vents to help prevent further water from entering the building.

Figure 15. *View of a plywood window panel that has warped and slipped. The existing panels should be replaced with painted, marine-grade plywood panels if the building is to remain vacant for an extended period of time.*

1. Replace existing plywood window and door panels with vented, painted, marine-grade plywood panels. Assume 18 windows at 30" x 48", 8 windows at 24" x 24," and three doors at 34" x 84". Install metal vent covers over panel vents.

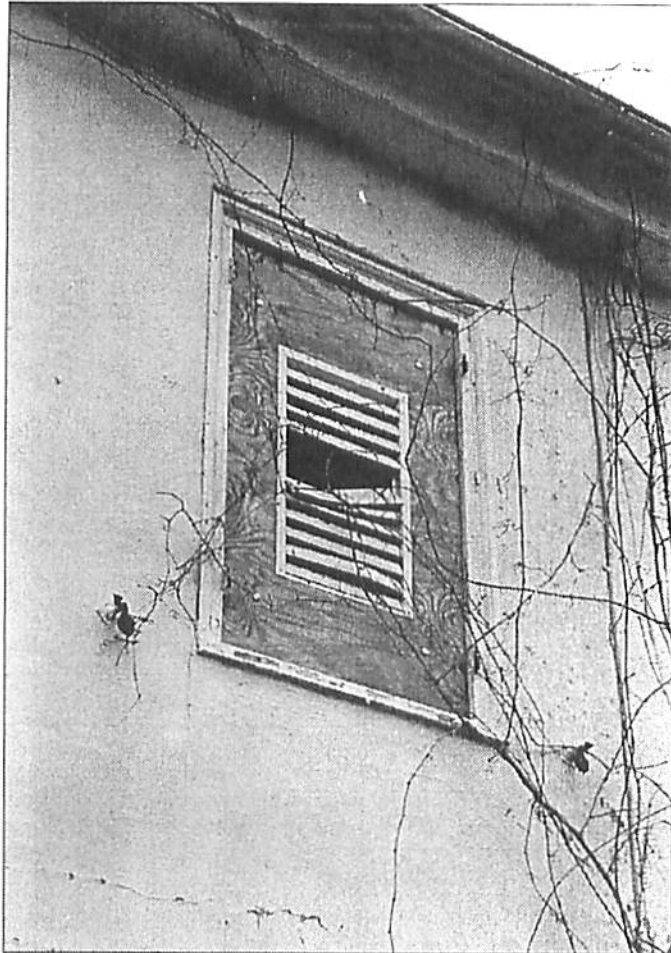
Figure 16. View of a broken louver on one of the plywood window panels. Replace plywood panels.

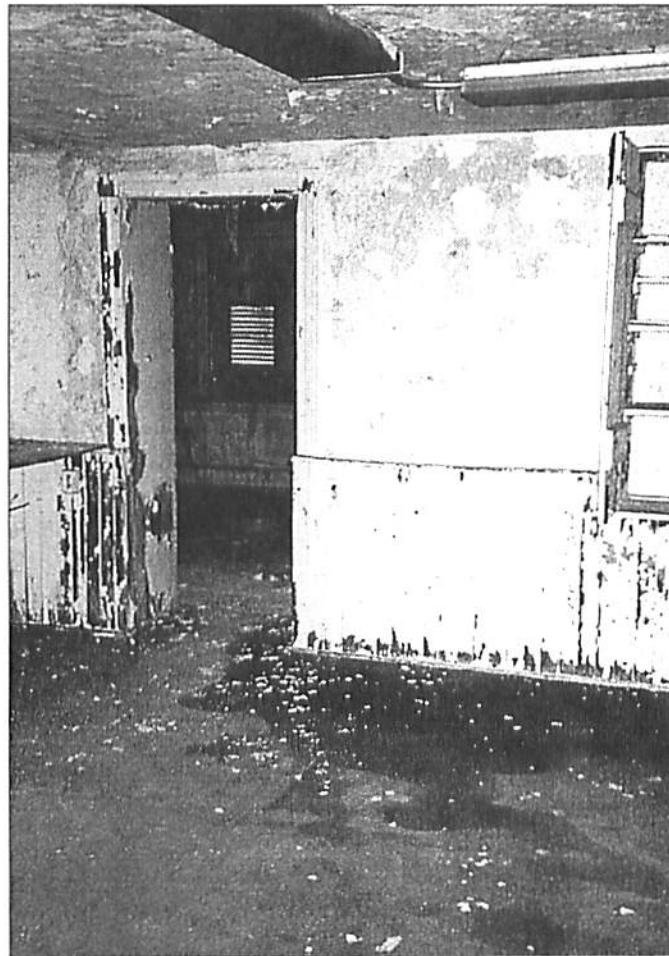
Figure 17. Water has infiltrated the interior of the building through the window louvers and wet the existing carpeting and flooring. Damp wood is appealing to insects and should be avoided.

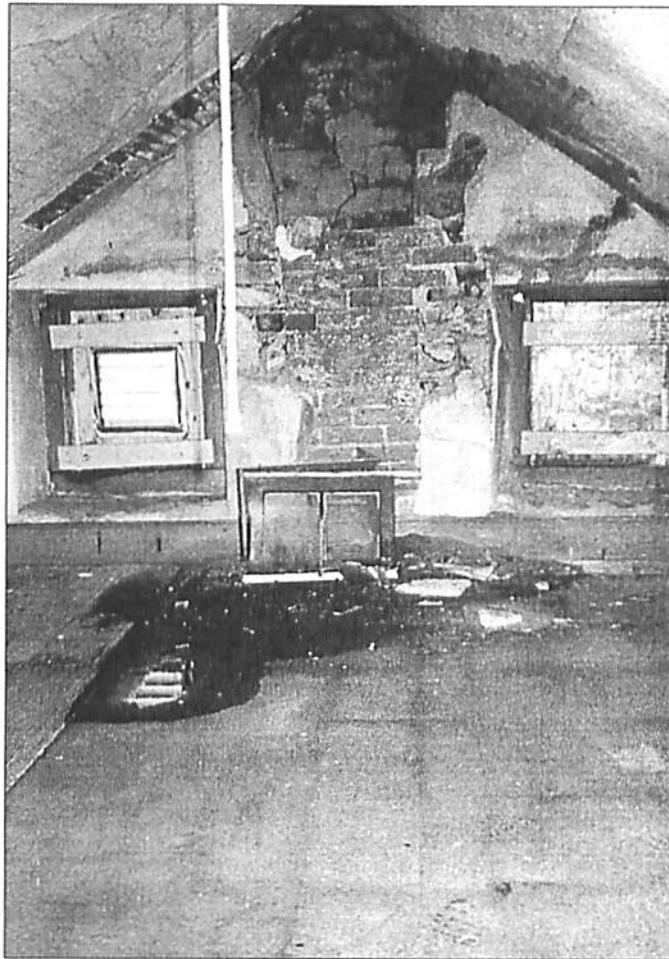
There are three masonry chimneys projecting through the roof of the Murphy House. While the chimneys appear to have been recently flashed, water infiltration and damage at the attic level suggests that more work is required to make these structures watertight. Spalled brick and stucco and puddles of water can be found at the base of the chimneys (Figure 18). The face of one chimney was also wet, as was the ceiling around it. To prevent further water damage to the Murphy House by way of the chimneys, it is recommended that all three chimneys be capped and repointed. The flashing at the bases of the chimneys should be checked and, if necessary, replaced.

Figure 18. View of a chimney base at the attic level. The chimneys on the house should be capped and repointed and their flashing checked to prevent further water from entering the building through them.

1. Cap three masonry chimneys. Assume each chimney is approximately 24" x 30" x 36" high.
2. Repoint same three chimneys.
3. Repair base flashing at same three chimneys.

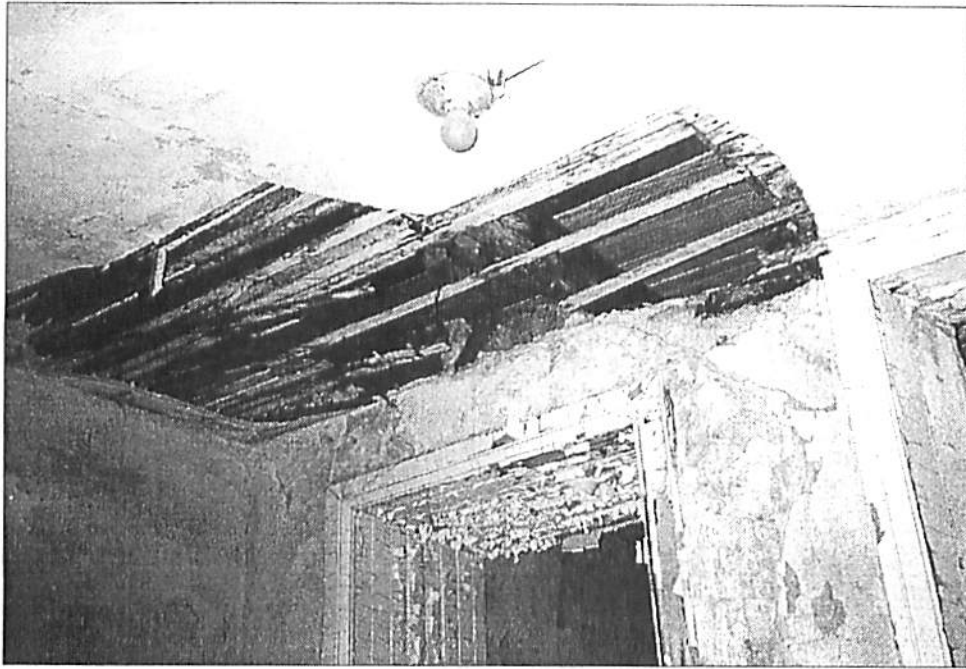
The interior finishes of the Murphy House are in fair to poor condition. Most of the visible damage to the building's interior can be attributed to past and present water infiltration. Paint is peeling from all surfaces including walls, ceilings, and window and door trim. Sections of plaster ceiling and ceiling lath have collapsed (Figure 19). The floors in the attic and many of the rooms on the first and second floors were wet at the time that the survey was conducted. The basement contained eleven inches of standing water (Figure 20). While it is not necessary to perform any repairs to the interior building finishes as part of the stabilization effort, steps should be taken to prevent further water damage. As discussed above, the roof should be checked above the area where water was entering the attic, repairs should be made to the masonry chimneys, and vents should be installed over the louvers in the plywood window panels. It is also recommended that a sump pump be installed in the basement complete with a water alarm that would inform the building's owners should the sump pump fail.

Figure 19: *Water damage has caused sections of ceiling plaster and lath to collapse.*

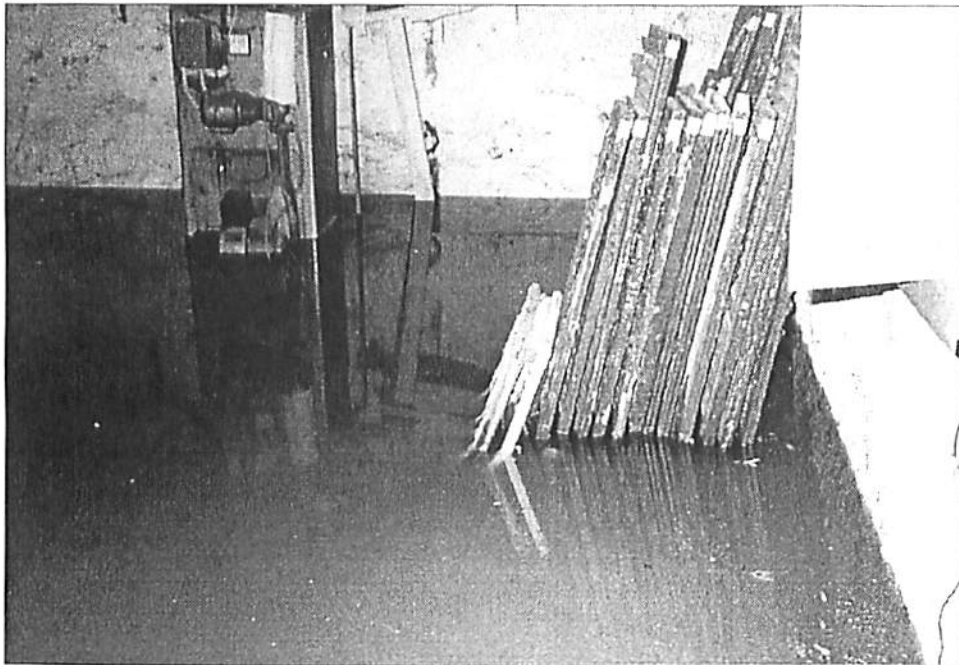
Figure 20. *At the time of the survey, there was eleven inches of standing water in the basement. A sump pump and alarm system should be installed in the basement to prevent further water damage to the structure.*

1. Install sump pump at basement level complete with remote-dial water-sensing alarm.
2. Have the building examined by a certified company for signs of active insect infestation and take necessary steps if evidence is found.
