Blue Ball Properties Master Plan

FEASIBILITY STUDY FOR THE STABILIZATION OF HISTORIC STRUCTURES

April 2000

The George Murphy House

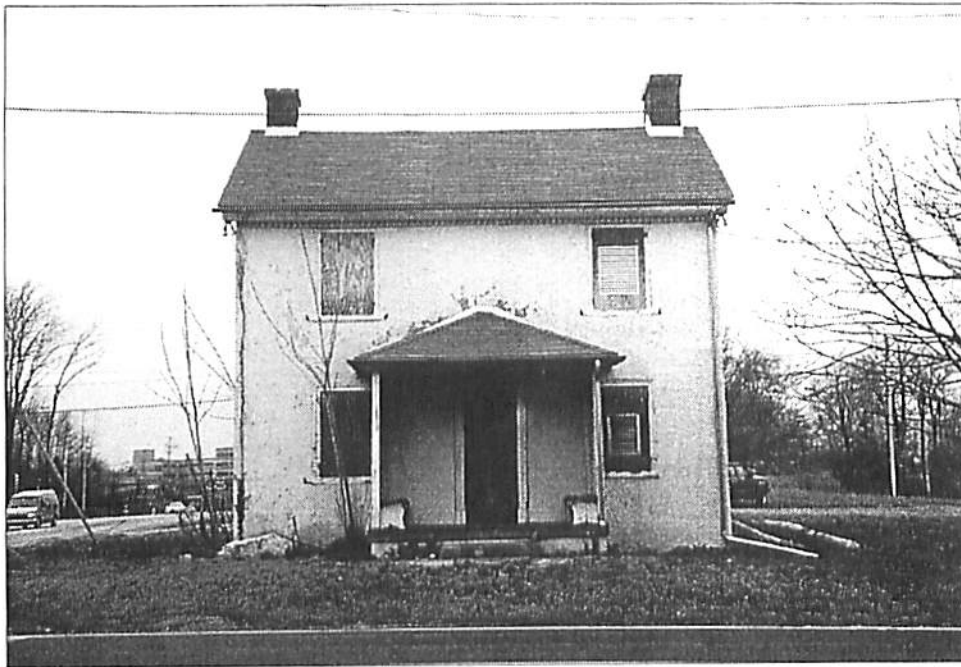
Figure 3. South elevation, the George Murphy House. View of the original stone portion of the structure.

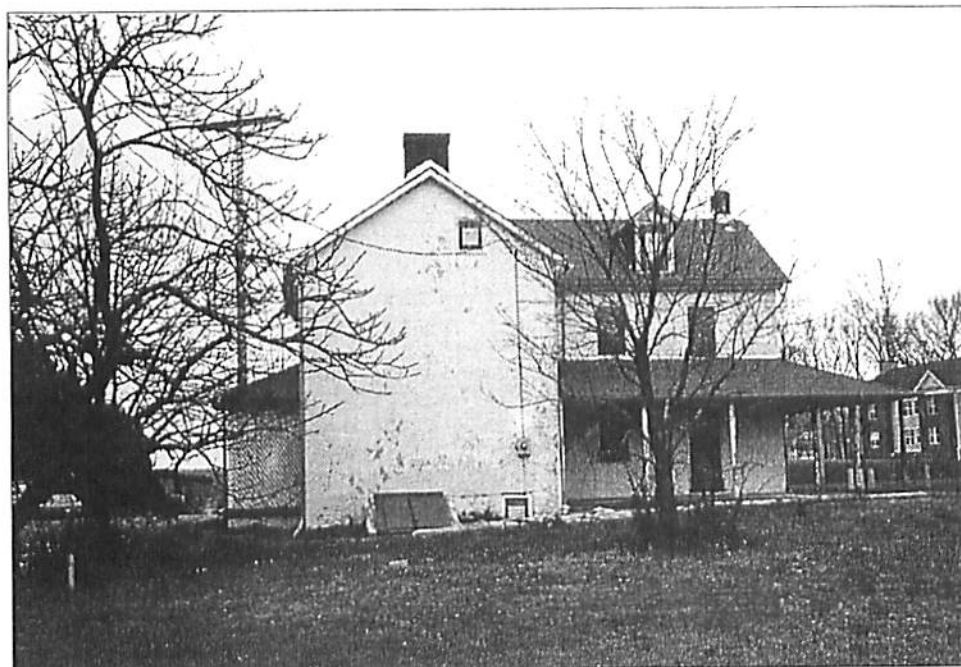
Figure 4. East elevation, the George Murphy House. View of the original stone portion of the structure and the frame addition with its wraparound wood porch.

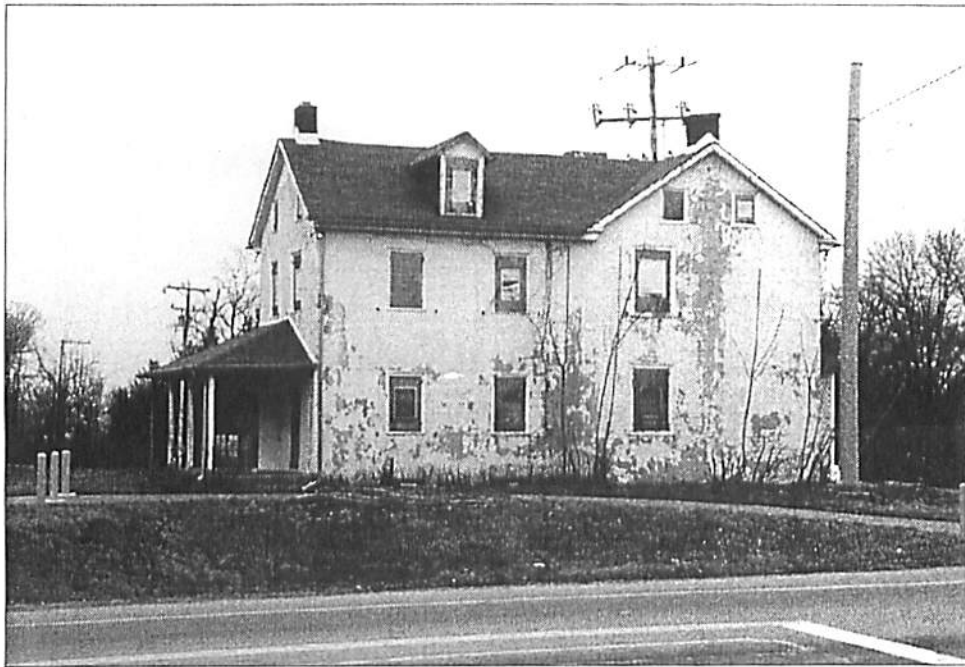
The stone and wood frame sections of the house share a new asphalt-shingled roof and new aluminum gutters and downspouts (Figures 5 & 11). The two porches also have new asphalt-shingled roofs and gutters. All of the roofs and gutters on the building are in excellent condition. The replacement of the old wood-shingle roofs on the building with new asphalt shingle roofs, new flashing, and new gutters have helped to effectively stabilize the building. While puddles of water were found on all levels of the house, very little of this water appears to have entered the structure through the roof. Only one minor roof leak was detected in the attic (Figure 12) below a valley where the roof of the frame

Figure 5 West elevation, the George Murphy House. The stone portion of the structure is to the right of the photograph, the frame ell is to the left.

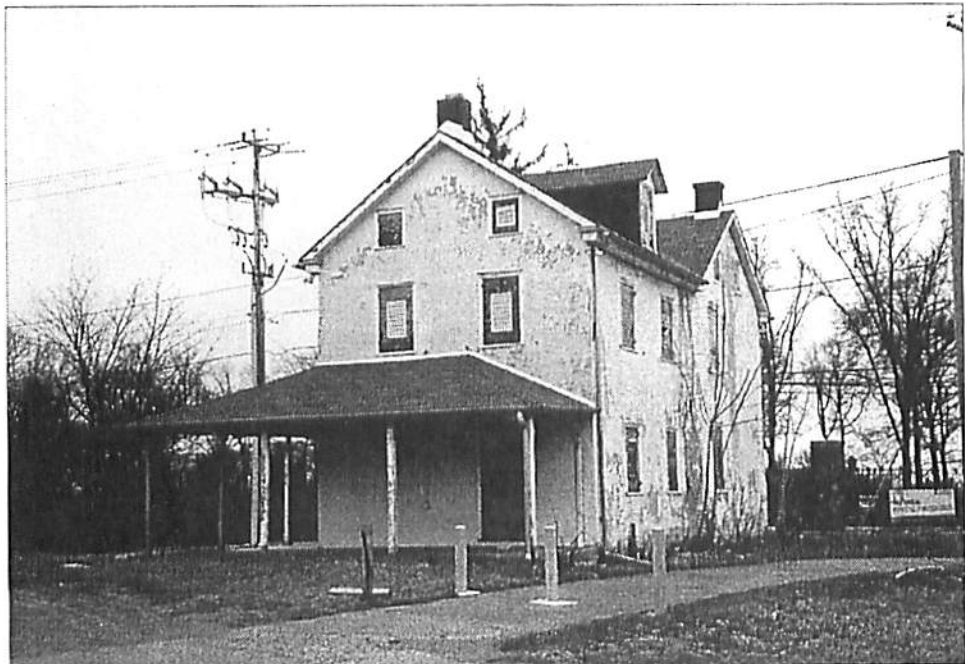
Figure 6. West elevation, the George Murphy House. The frame addition to the house is in the foreground.
